**BLACKSTONE RIVER BASIN  
MILLBURY, MASSACHUSETTS**

**DOROTHY POND DAM  
MA 00146**

# **PHASE I INSPECTION REPORT NATIONAL DAM INSPECTION PROGRAM**

**JULY 1978**

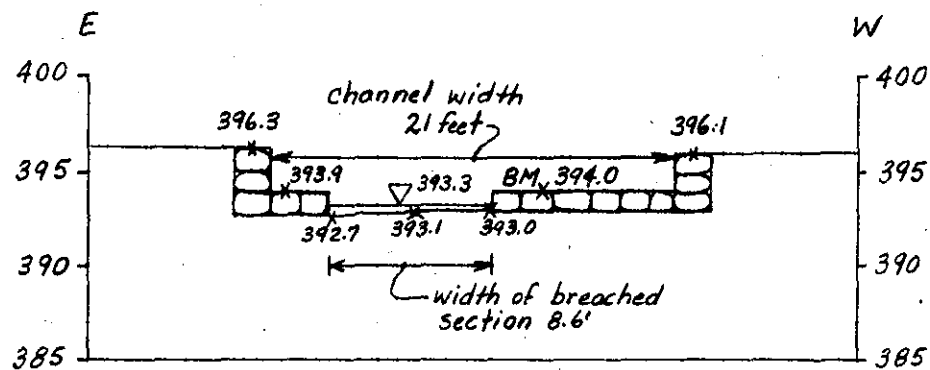
SPILLWAY SECTION 2-2

The spillway crest had been partially lowered 12 inches in 1955 (See Figure B-2) because of upstream flooding. This indicates that small changes in pond elevation could cause localized flooding to residences near the shoreline.

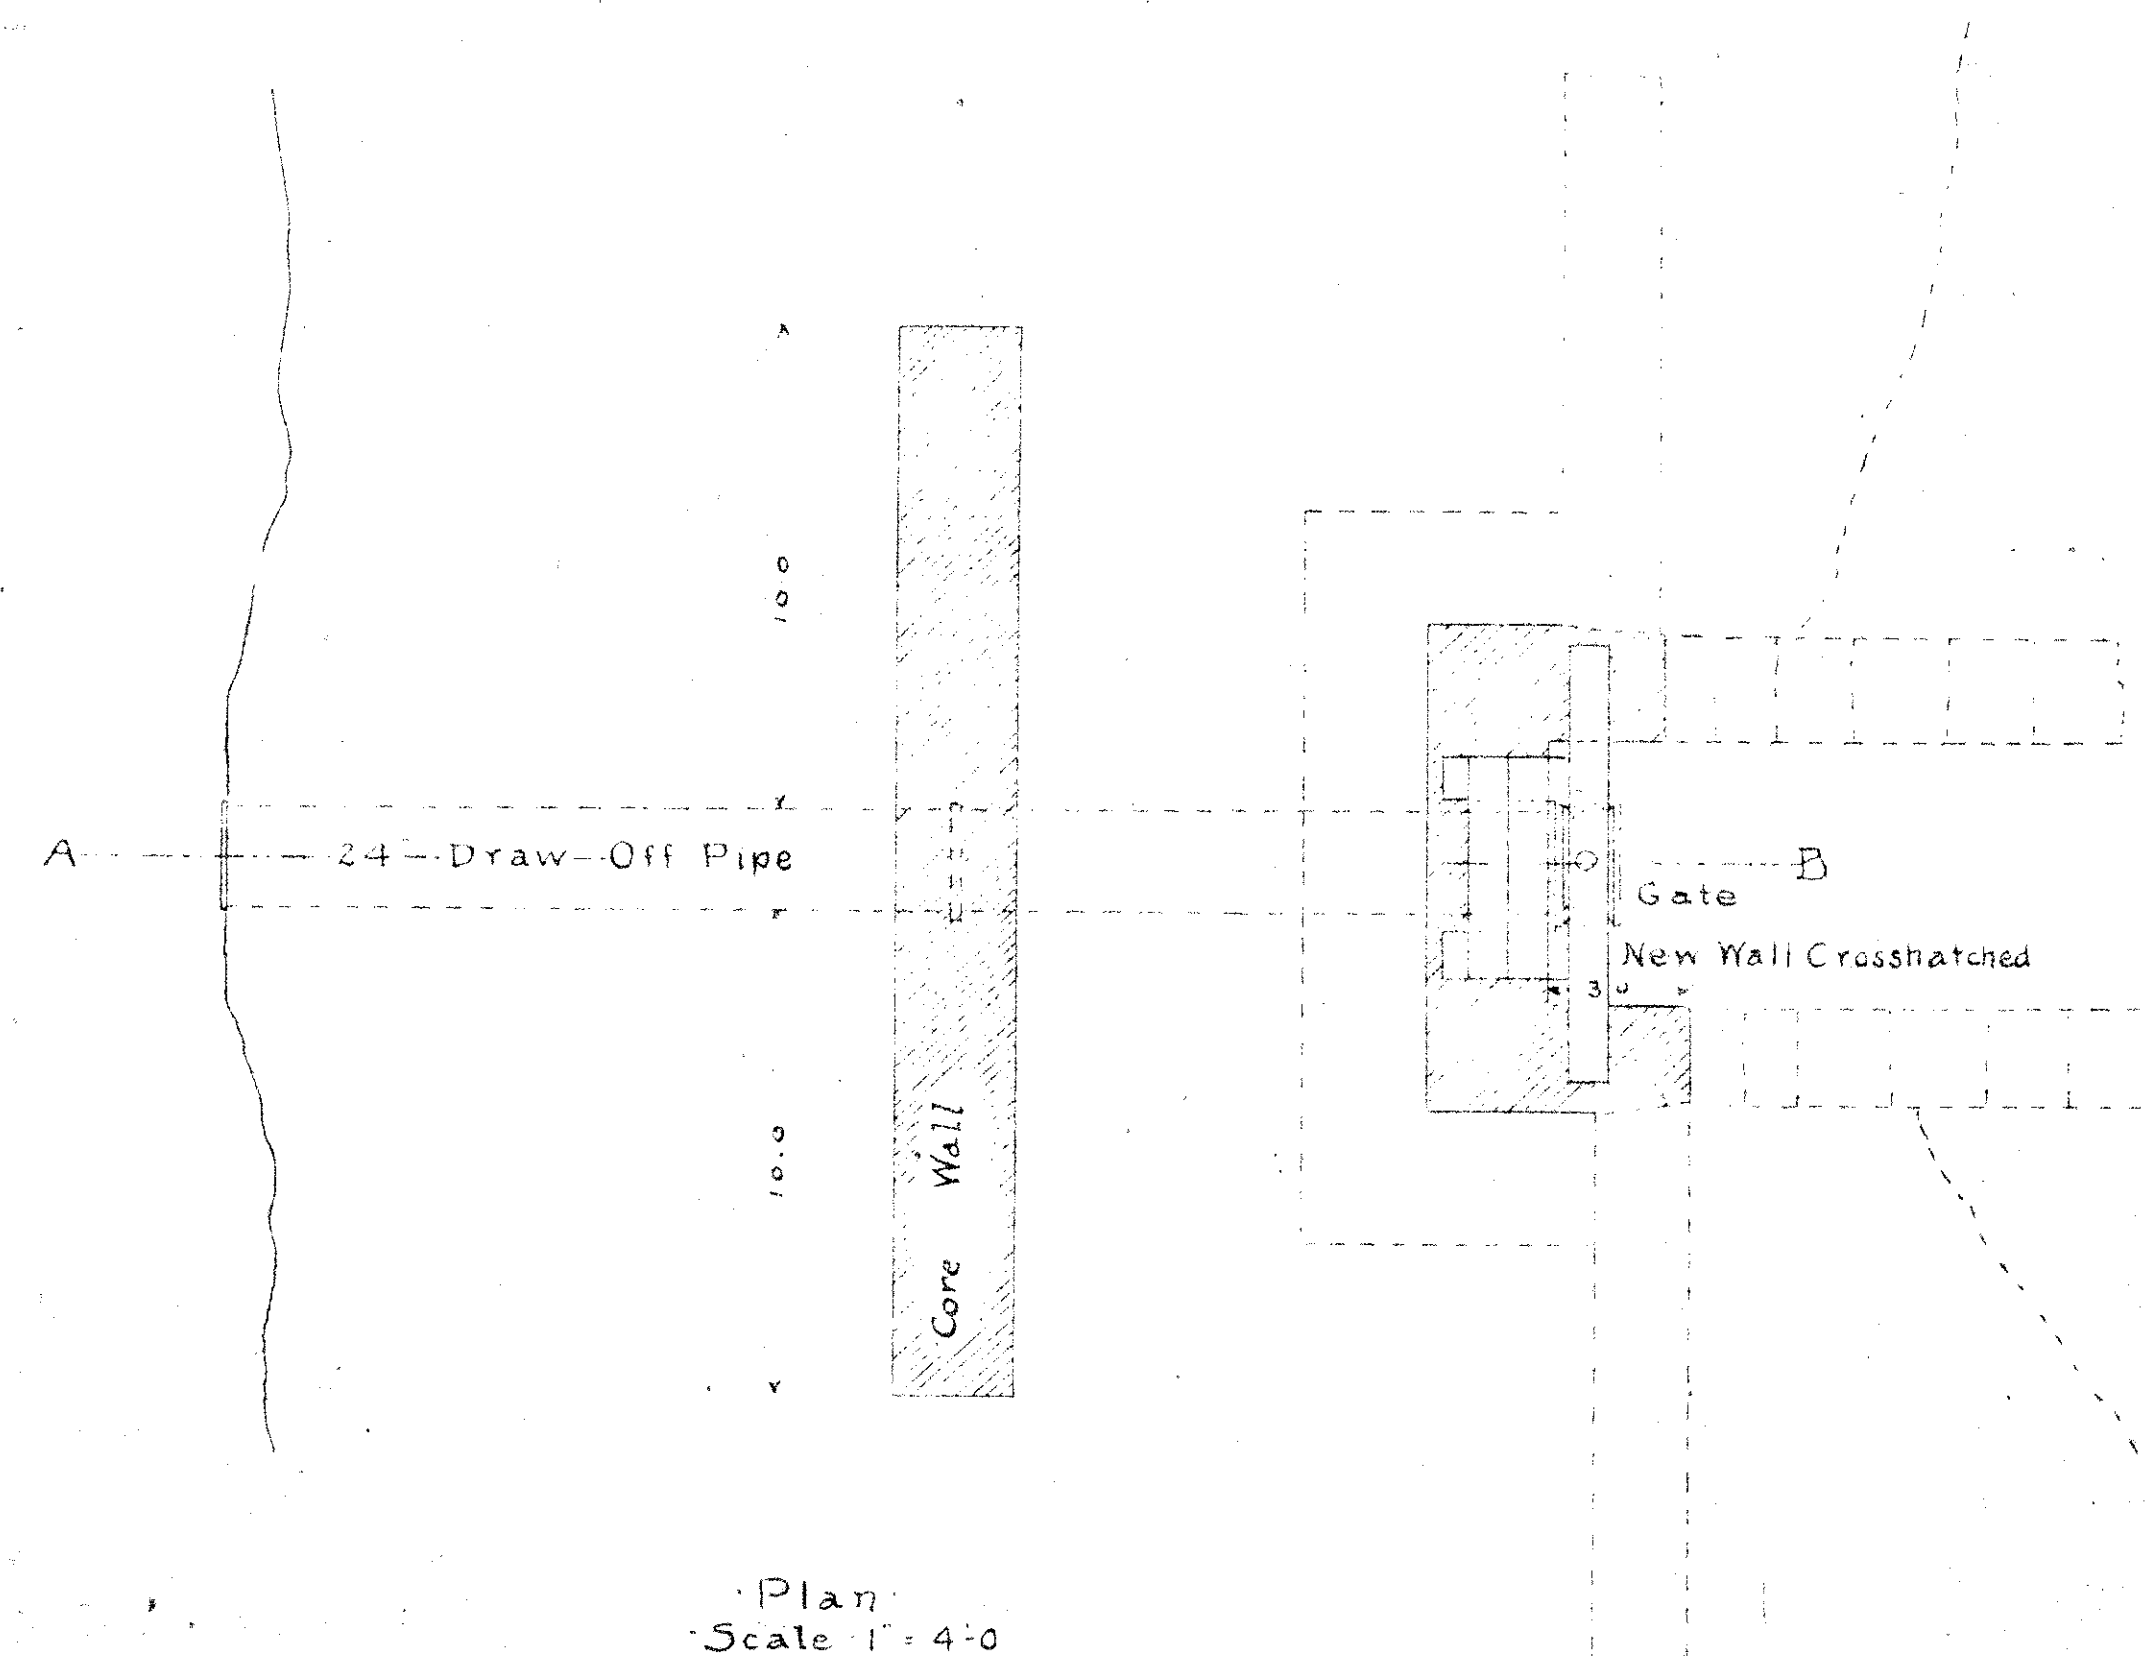
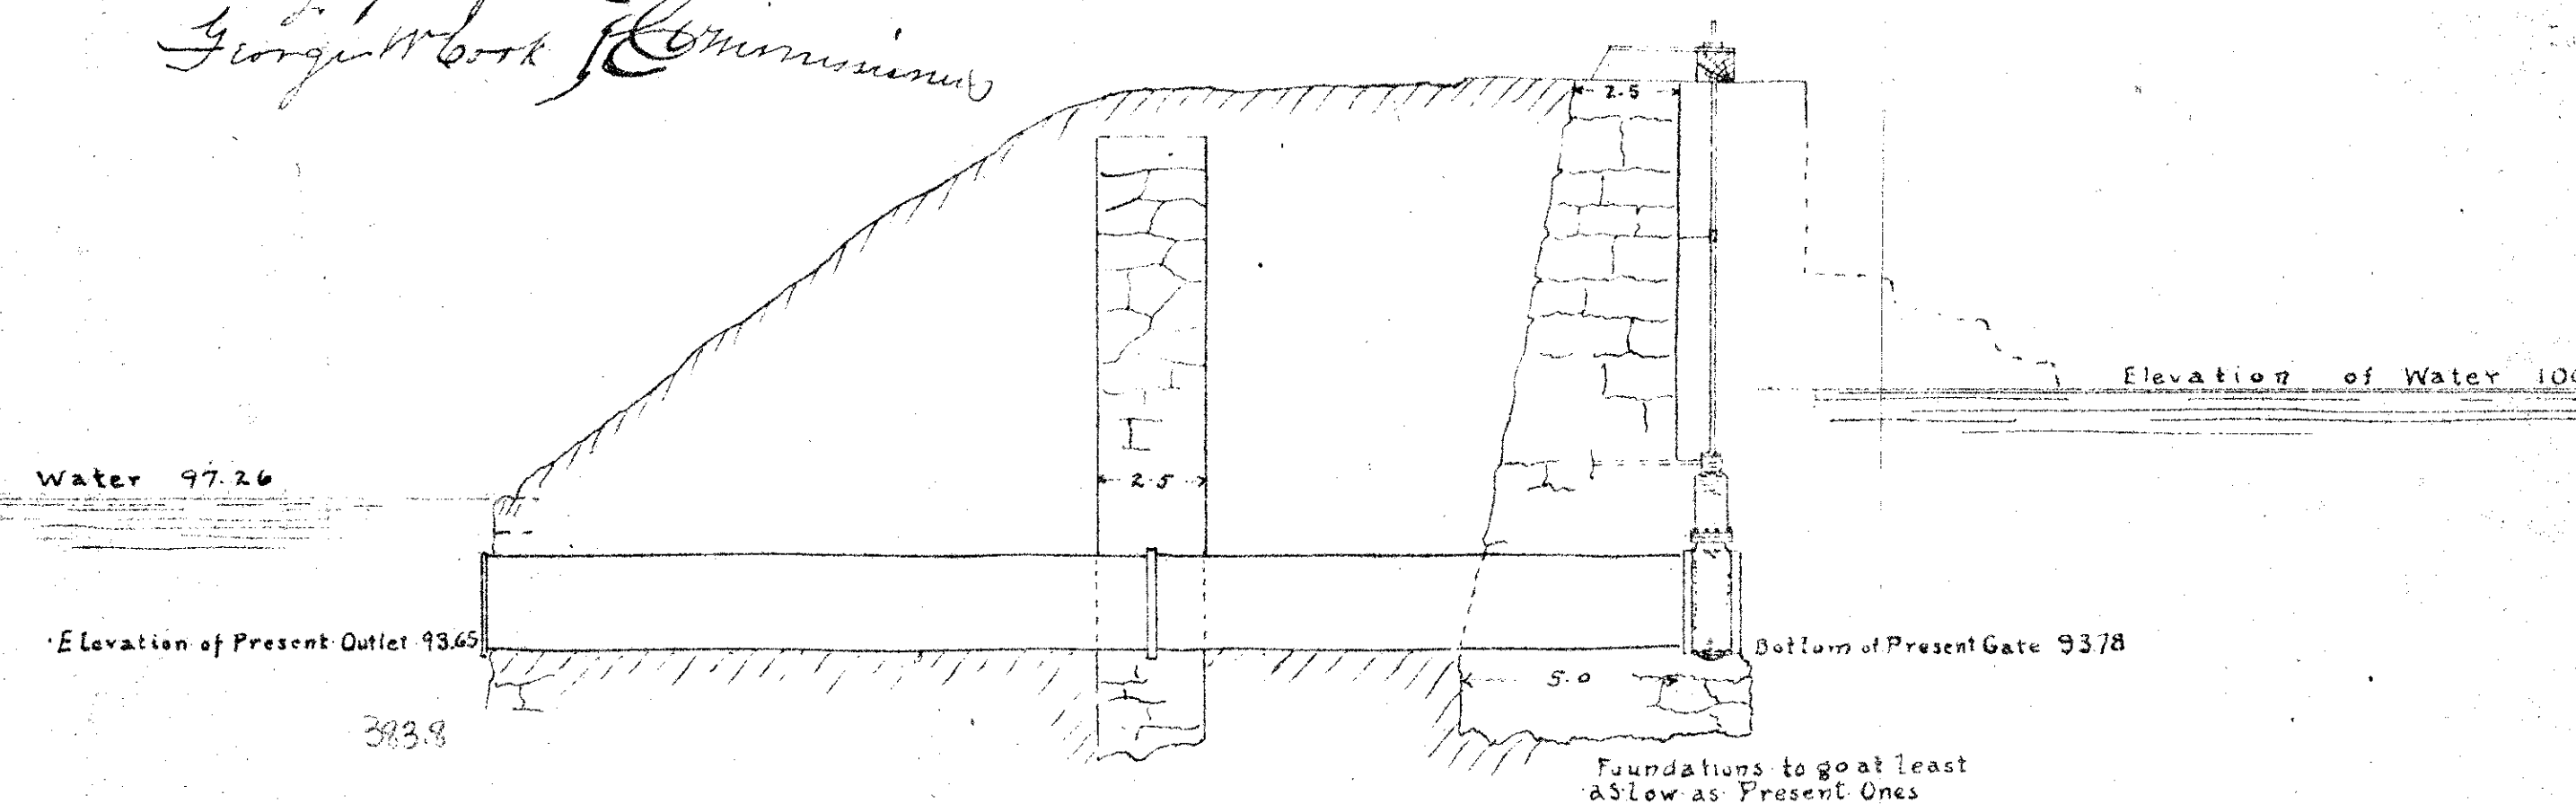
Plans of Proposed Changes in Outlet  
Dorothy Pond Dam  
Buck Bros Millbury Mass.  
Engineer Aug 27 1900

It was learned that this dam was built in 1825, probably of local soil or rock materials. As noted above, Figure B-3, shows a proposed stone masonry core wall. This core wall is shown to be 22-feet long by 14-feet high by 2.5-feet thick and is located 13 feet from the outlet conduit headwall. Since the dam is about 200 feet long, the core wall only extends for about 10 percent of the total length.

- d. Post-Construction Changes. There are no as-built drawings for Dorothy Pond Dam. Modifications to the original dam were proposed by Buck Brothers, Inc. in 1900. (See Figure B-3.) There is no as-built information relative to these changes. It was reported by Mr. Cort that the spillway elevation was raised about 18 inches at some unknown time. In 1955, Mr. Cort partially removed this raised spillway section. The slide gate for the outlet conduit was repaired in 1960 and subsequently replaced in 1970.

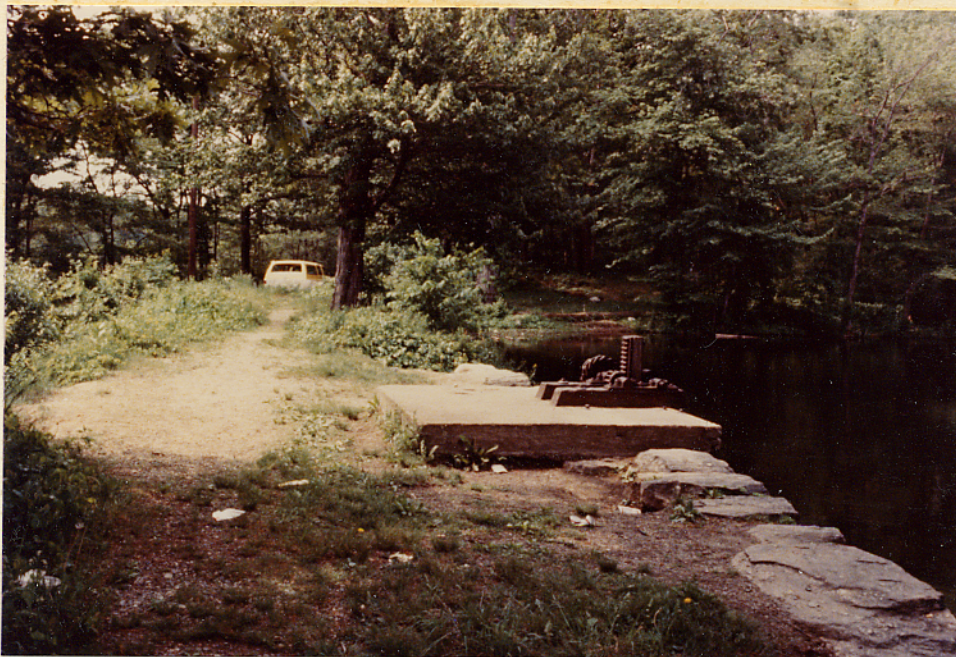
**NO. 1 - SOUTHWEST VIEW OF TOP OF DAM**

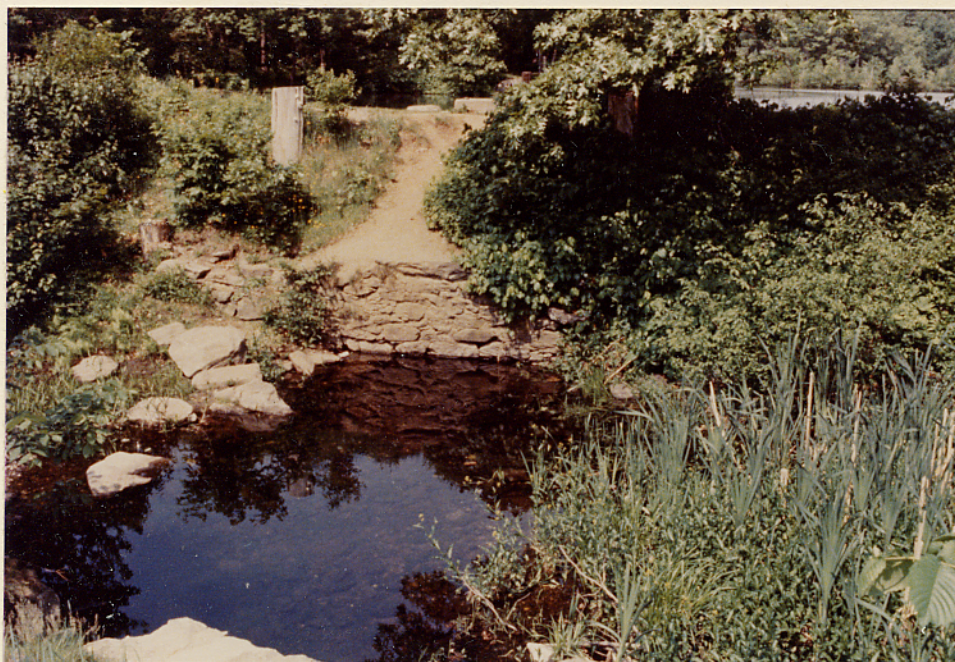
- c. Appurtenant Structures. The outlet structure is a 24-inch diameter cast-iron pipe surrounded by a mortared masonry headwall 7-feet high. The rim of the pipe is rusted, and the mortar in the headwall is deteriorated and missing in places. Downstream beneath Riverlin Street is a 54-inch diameter corrugated metal culvert with upstream and downstream headwalls. The headwalls of mortared masonry have deteriorated. The southern end of the upstream headwall has several missing stones apparently caused by surface runoff from Riverlin Street.

**NO. 2 - VIEW OF OUTLET AND STILLING POOL**

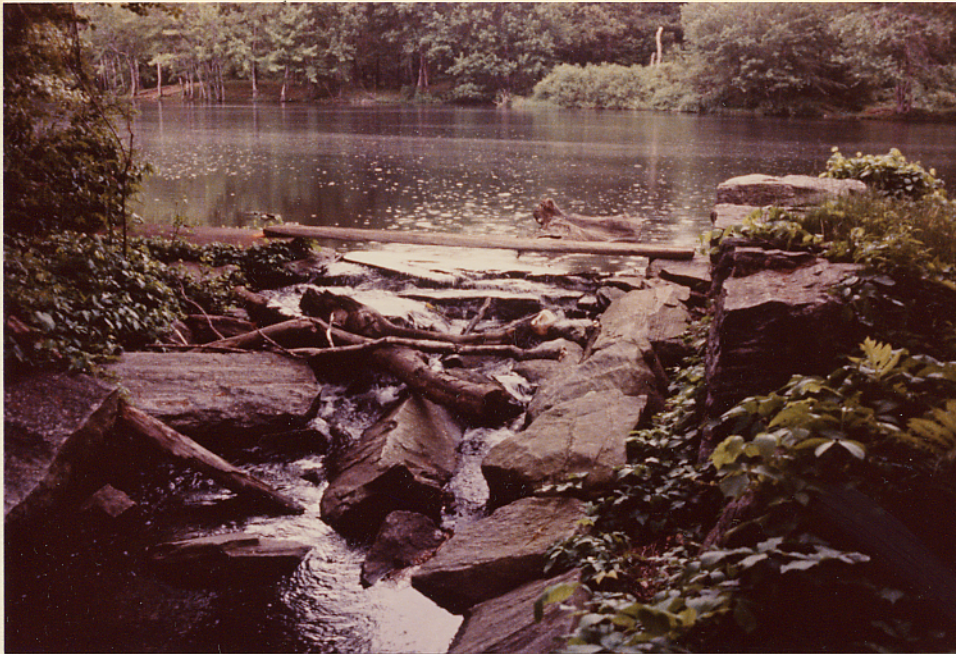
The spillway channel is constructed of mortared masonry sidewalls. The bottom is partially lined with mortared riprap and partially covered with loose, randomly placed riprap. A few masonry blocks are missing out of place from the sidewalls and the mortar is deteriorated. The spillway channel is strewn with various debris such as fallen wood, tires, and dislocated rock blocks.

**NO. 3 - VIEW OF SPILLWAY**

- (1) remove the trees on the dam and clear all debris from the spillway;
  - (2) repair erosion of the upstream headwall and dam face, and install riprap to prevent continued deterioration of the dam;

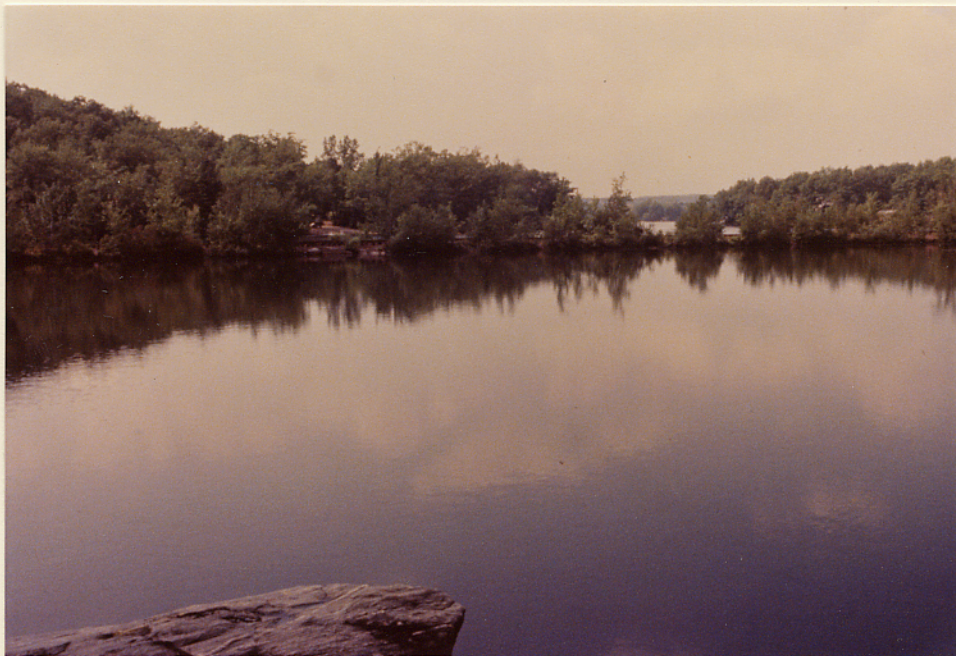
**NO. 4 - VIEW OF RAILROAD EMBANKMENT, LOOKING UPSTREAM**
